# WESTERN FARMERS ELECTRIC COOPERATIVE

October 17, 2016  
Combined Initial Hazard  
Potential Classification,  
Structural Stability, and Safety  
Factor Assessment Report

**OK00032129**

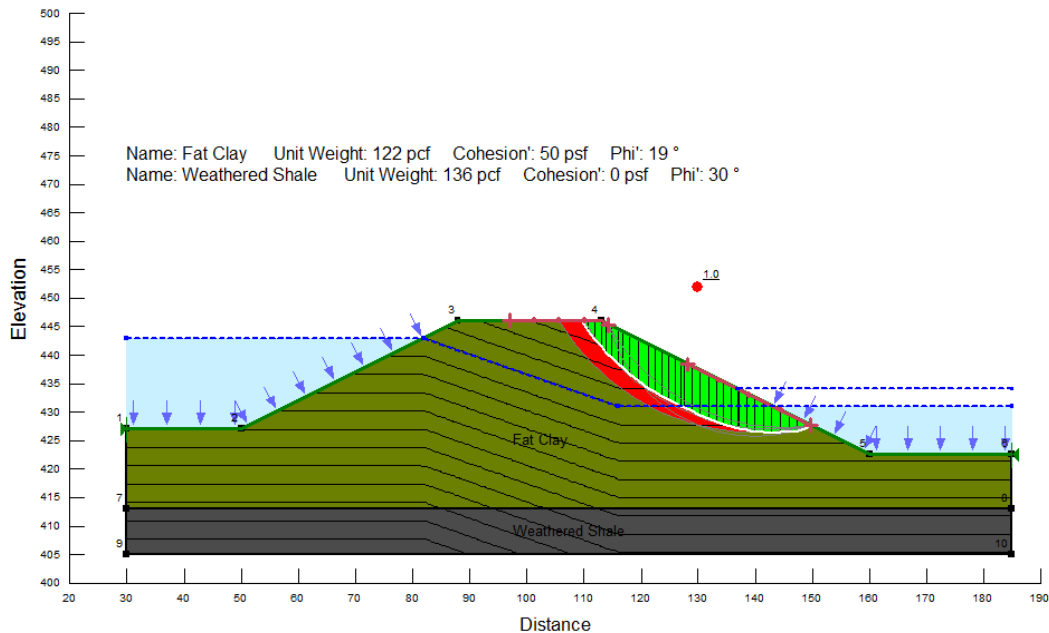
- The existing condition of the Impoundment east embankment with a slope of 2H:1V has a safety factor of 1.0
- Rebuilding the top eight feet of the Impoundment east embankment outslope with a geogrid material, maintaining the 2H:1V slope, results in a safety factor of 1.5 (Terracon Report Alternative 2)
- Modifying the outslope of the Impoundment east embankment to 3H:1V slope results in a safety factor of 1.5 (Terracon Alternative 3)

FIGURE 1: EXISTING 2H:1V SLOPE

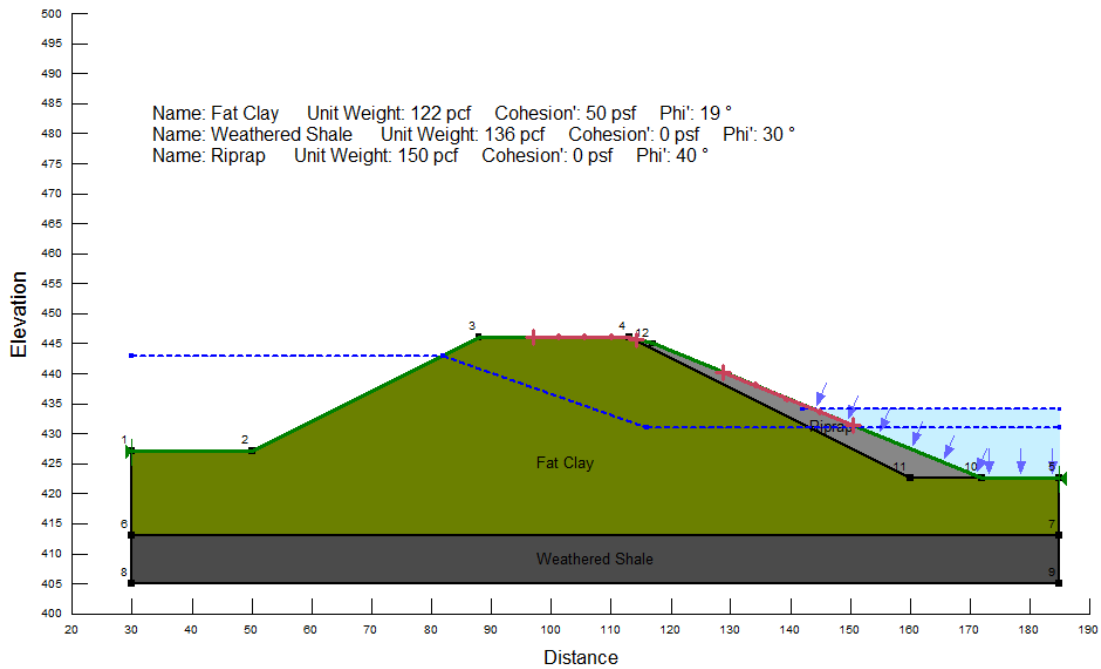
**FIGURE 2: ALTERNATIVE 1 - 2H:1V SLOPE - WITH RIP RAP**

Analysis of this new reconstructed slope indicated a safety factor of around 1.3 as shown in Figure 3.

The outer layer of riprap should extend laterally 12 feet from the toe and 3 feet from the crest of the embankment. The riprap should be hard, sound and durable, crushed stone meeting ODOT Specifications 713.02. The stone should be well graded with an average stone size (D50) of 24 inches, placed and compacted to maximize density and aggregate interlock between stones.

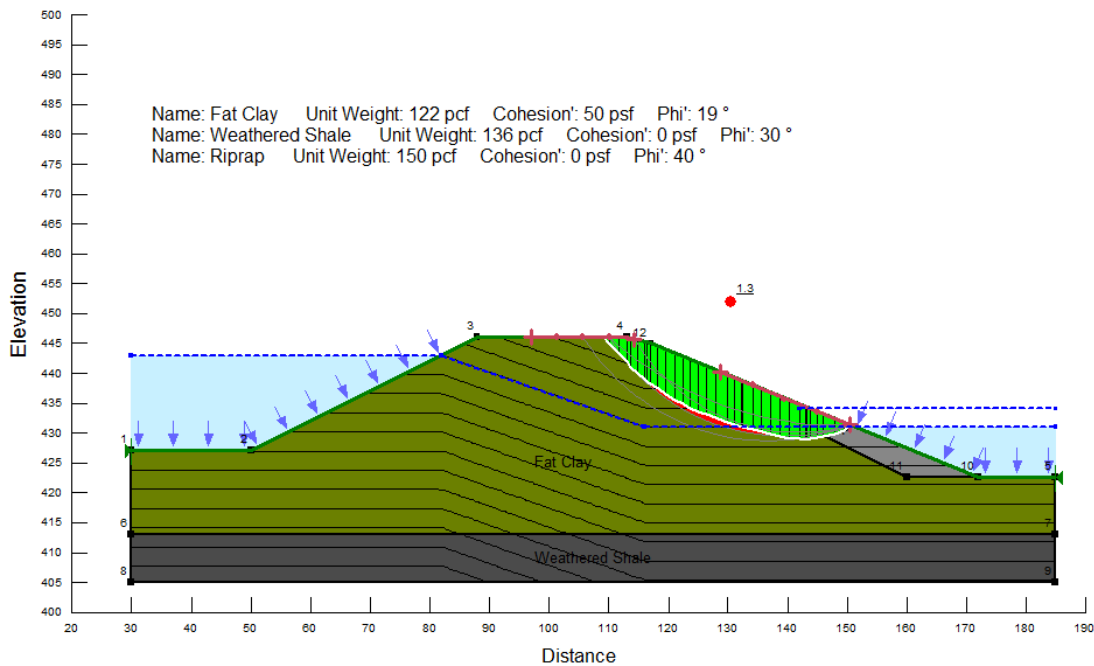
**FIGURE 3: ALTERNATIVE 1 - FACTOR OF SAFETY IS 1.3**

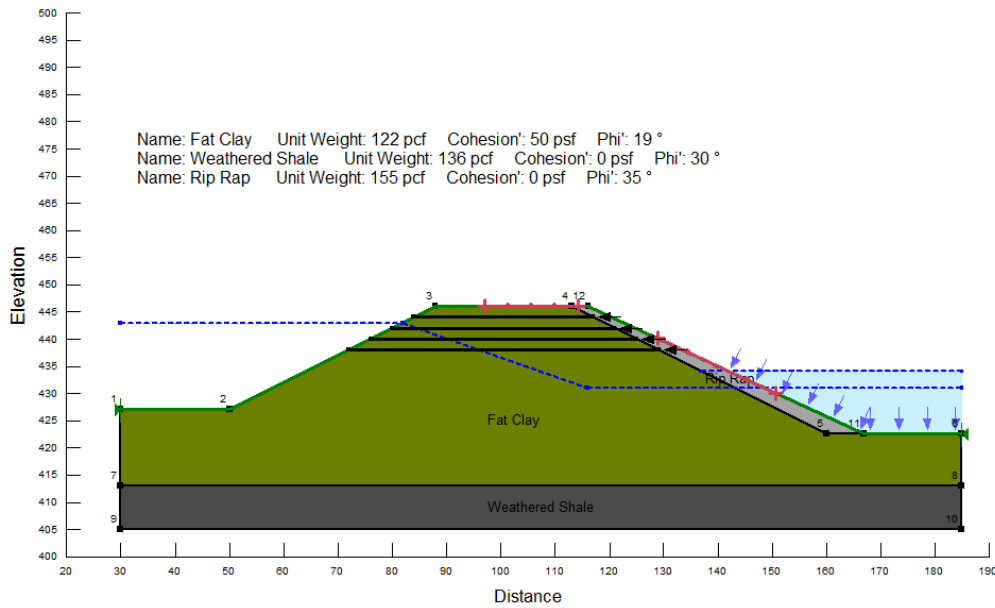
**FIGURE 4: ALTERNATIVE 2 - 2H:1V REINFORCED SLOPE – WITH RIPRAP**

Alternative 2 consists of reinforcing the existing 2H:1V slope using a geogrid with a minimum long-term design strength (LTDS) of 3,000 pounds per lineal foot, similar to Miragrid 7XT. The top 8 feet of the embankment would be reconstructed and the geogrid reinforcement layers would be placed every two feet vertically up the slope. as shown in Figure 4. Four layers of reinforcement would be required to provide a factor of safety of approximately 1.5 as shown in Figure 5. Each layer of reinforcement would be extended the width of the embankment. Fill should be placed in lift thicknesses of no more than 8 inches, within 2 percent of its optimum moisture content, and be compacted to at least 95 percent of the material's maximum dry density as determined by test method AASHTO T-99 (standard Proctor).

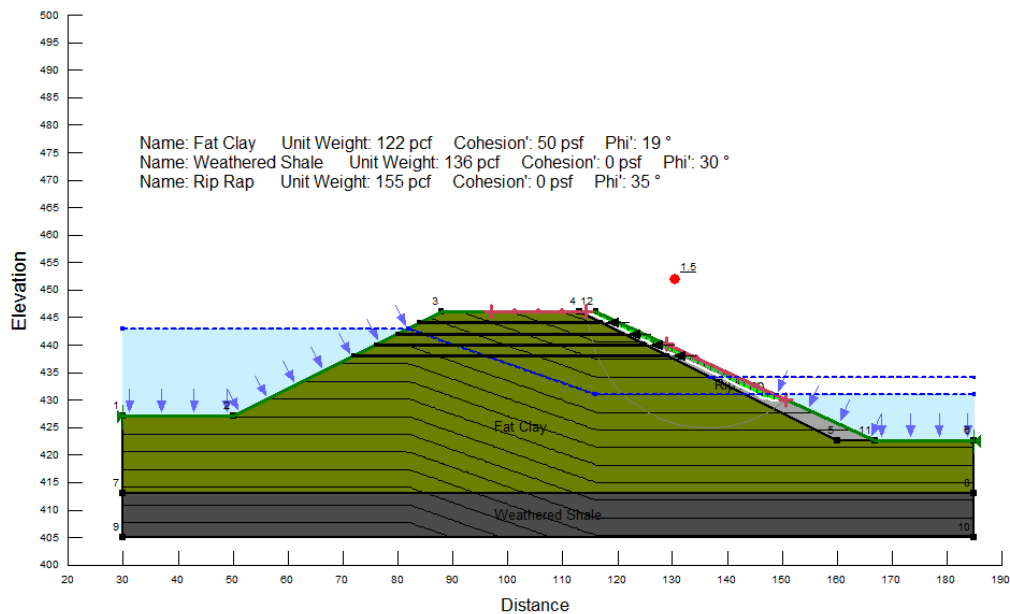
**FIGURE 5: ALTERNATIVE 2 - FACTOR OF SAFETY IS 1.5**

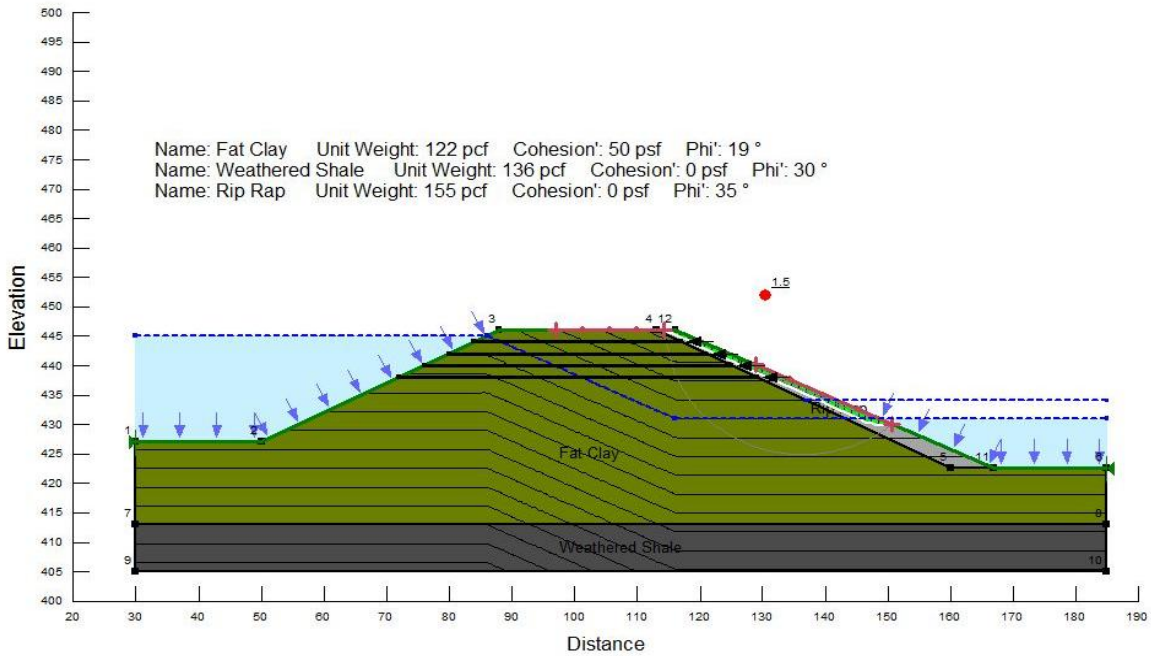
**FIGURE 6: ALTERNATIVE 2 AT POOL 445 FT. - FACTOR OF SAFETY IS 1.5**

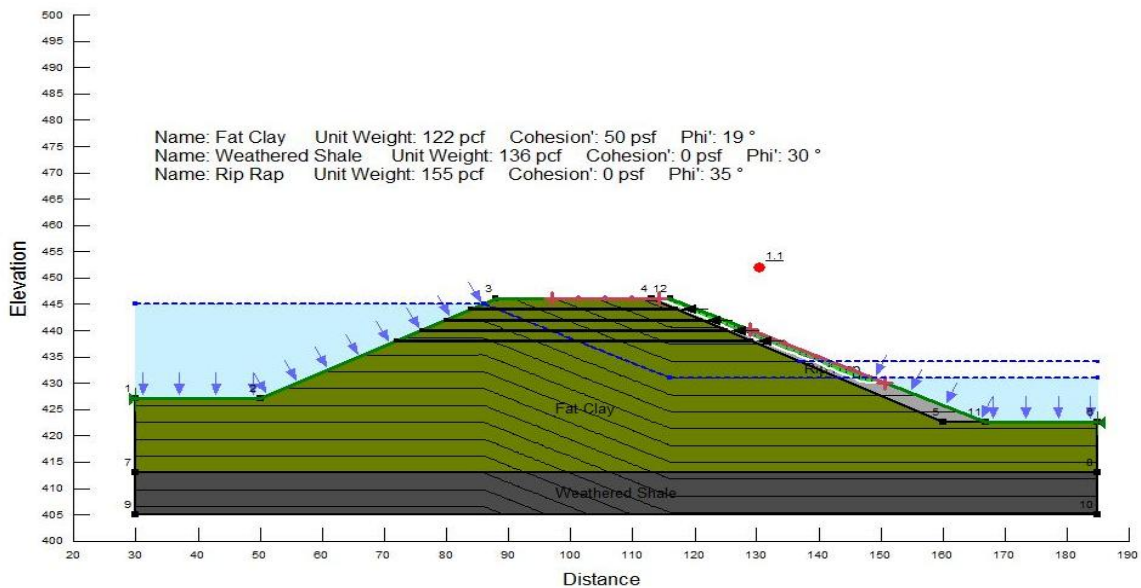
using SlopeW. Based upon further literature review, these coefficients provide results that are conservative for this region with regards to the analysis of seismic induced loads on the embankment slope. Using this information, a safety factor of 1.1 was achieved as shown in Figure 7.

**FIGURE 7: ALTERNATIVE 2 AT POOL 445 FT. WITH SEISMIC LOADS - FACTOR OF SAFETY IS 1.1**

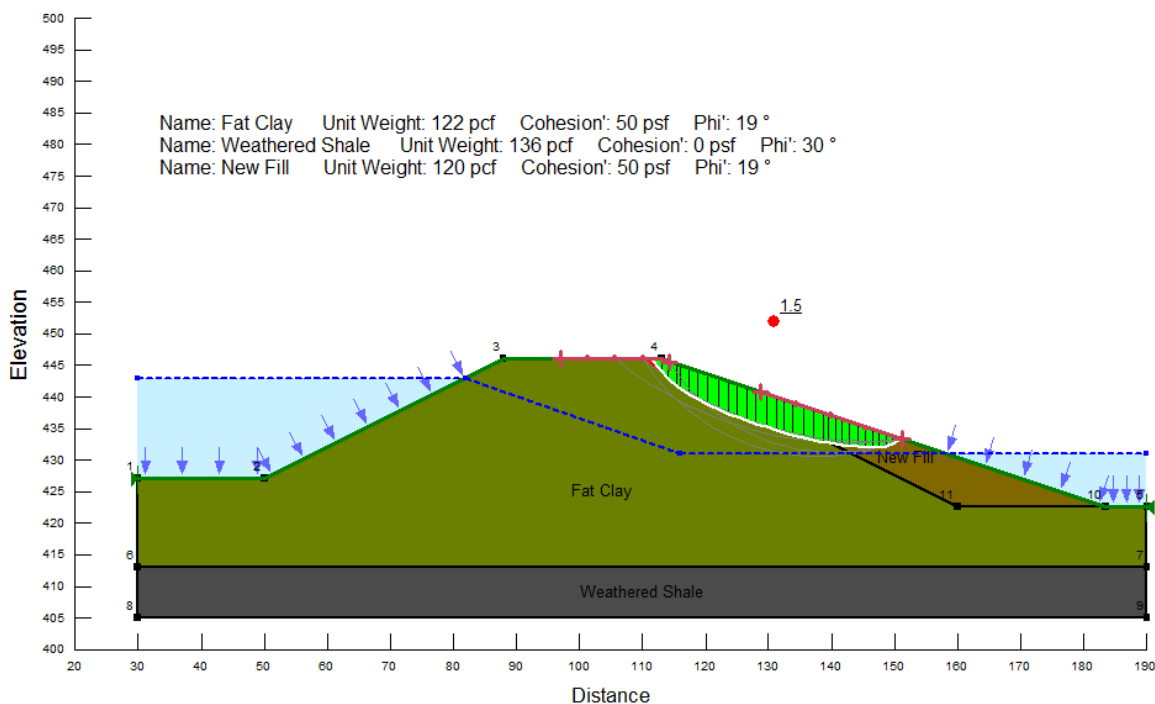
**FIGURE 8: SLOPE MODIFIED TO 3H:1V TO ACHIEVE SAFETY FACTOR OF 1.5**

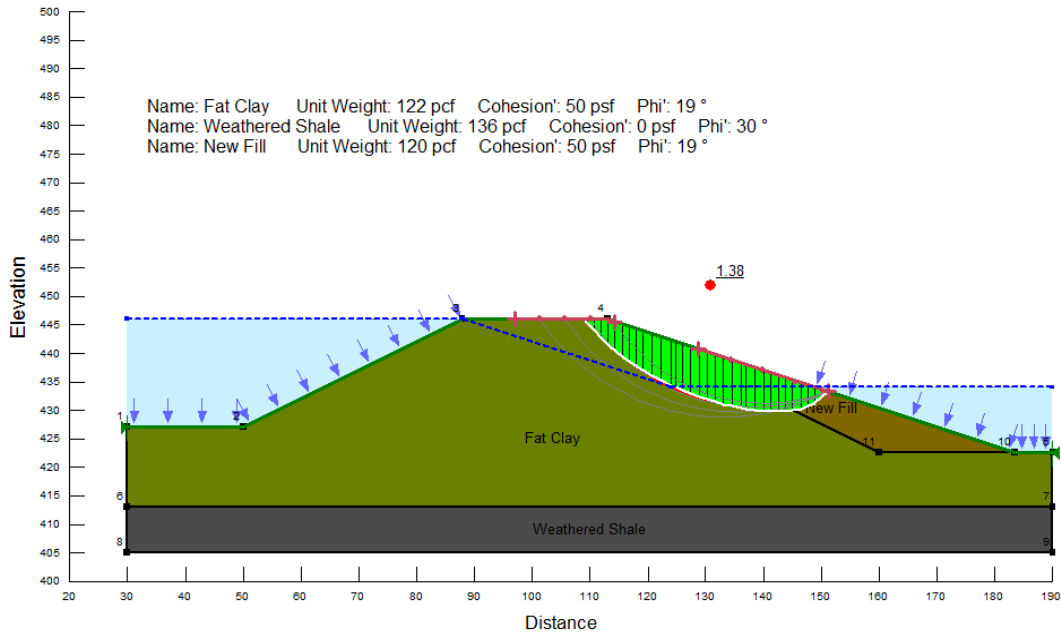
If the water surface elevation was able to reach the top of the embankment, this would place the water elevation at 446.0 feet. Additional analysis using SlopeW indicates that increasing the water elevation to 446.0 feet for the 3H:1V slope achieved a safety factor of 1.38 as shown in Figure 9 below.

**FIGURE 9: ALTERNATIVE 3 WITH MAXIMUM WATER ELEVATION - FACTOR OF SAFETY IS 1.38**

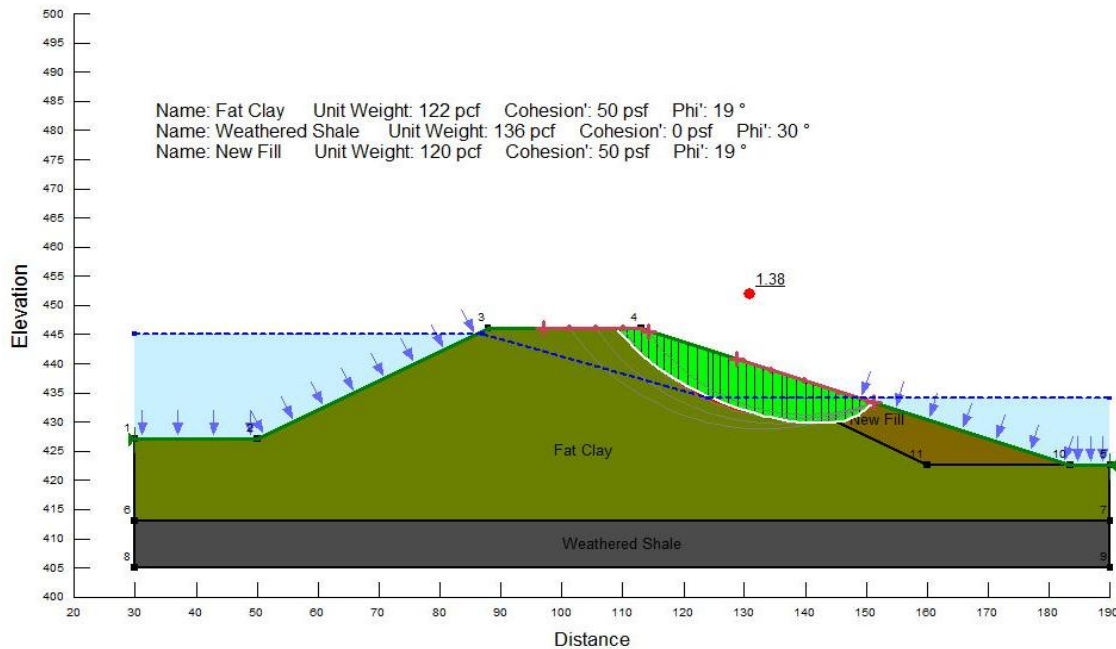
Analysis of the of the 3H:1V slope with a reduced pool elevation of 445 produced little difference in factor of safety still achieving a safety factor of 1.38 as shown in Figure 10 below.

**FIGURE 10: ALTERNATIVE 3 AT POOL 445 FT. - FACTOR OF SAFETY IS 1.38**

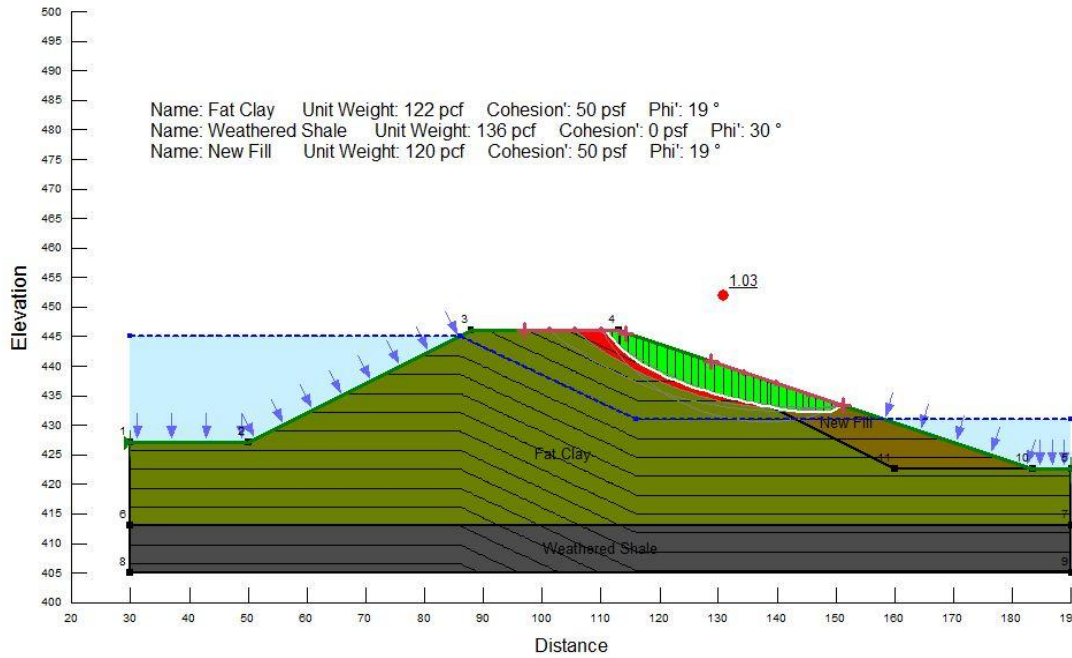
A final analysis of alternative 3 at a pool elevation of 445 feet with seismic loads produced a factor of safety of 1.03 as shown in Figure 11.

**Figure 11: Alternative 3 at pool 445 ft. with seismic loads - Factor of Safety is 1.03**

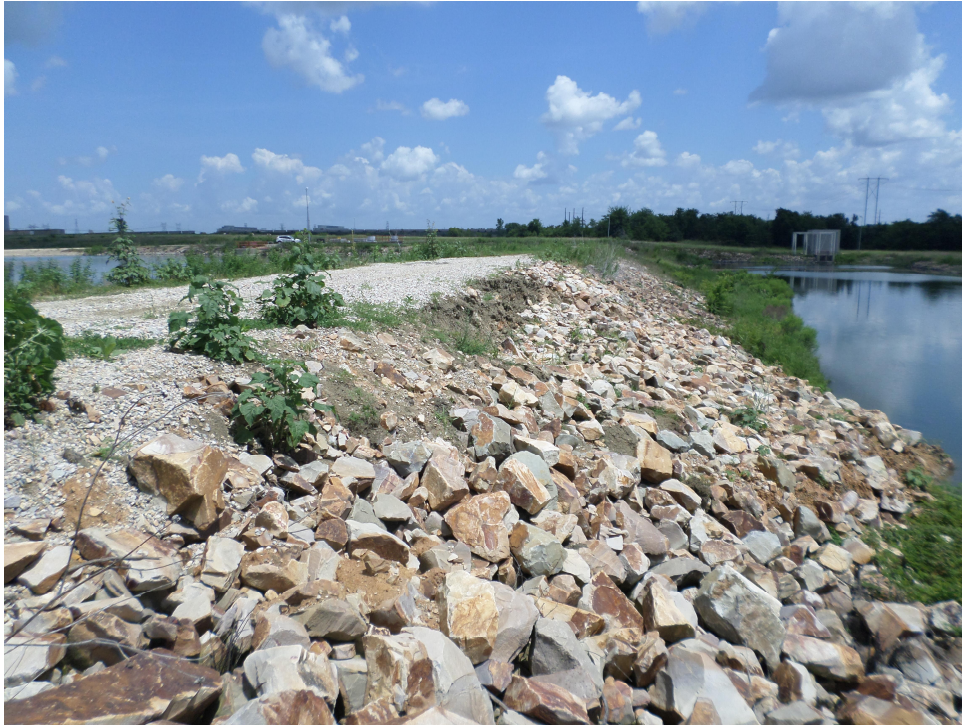
ITEM	DESCRIPTION
Existing conditions	<ul style="list-style-type: none"> <li>n A small landslide approximately 30 to 40 feet long has appeared on the downstream portion of the southeast detention pond embankment. The embankment has dropped approximately 4 to 5 feet along the edge of the road atop the crest.</li> <li>n There are several small scarps or slides along the slopes of the detention ponds.</li> <li>n A portion of the embankment is covered with vegetation consisting of small trees, shrubs, grasses and weeds.</li> <li>n The rip rap on the embankment is not uniform and does not provide adequate protection of the slopes.</li> </ul>

Embankment slopes constructed of high plasticity clays, such as this embankment, although stable when originally constructed, experience shrink and swell movements during alternating wet / dry weather cycles. This shrink / swell activity tends to form cracks along the slope face which allow more water into the near surface zone along the slope causing it to swell and soften to a greater depth. This swelling/softening activity forms a weaker zone of soil along the surface of the embankment. The soils in this zone of the embankment become progressively more normally consolidated and can approach what is termed a “fully softened” condition. Creep and ongoing weathering can further reduce the shear strength of the soil in this zone, causing progressive strain-softening, leading to a residual strength condition in portions of the slope. Slopes of this nature can begin to fail progressively, either in a bottom-up, or top-down fashion, leading to full mobilization of the entire slope. In the case of this embankment, it appears that the failure is a top-down progression. Any tension crack that formed at the crest of the slope likely served to introduce additional water seepage into the shear surface causing further shear strength reduction and downslope progression. During the site visit to the facility, discussions with the Plant Engineer indicated the slide occurred after a series of heavy rain events in the

area. Given the long dry periods that have been occurring in recent years, it is probable that shrinkage cracks developed in the embankment that allowed water to infiltrate into the embankment slope thus accelerating the shrink swell cycle.

**No.1** - Slide on Downslope of Embankment

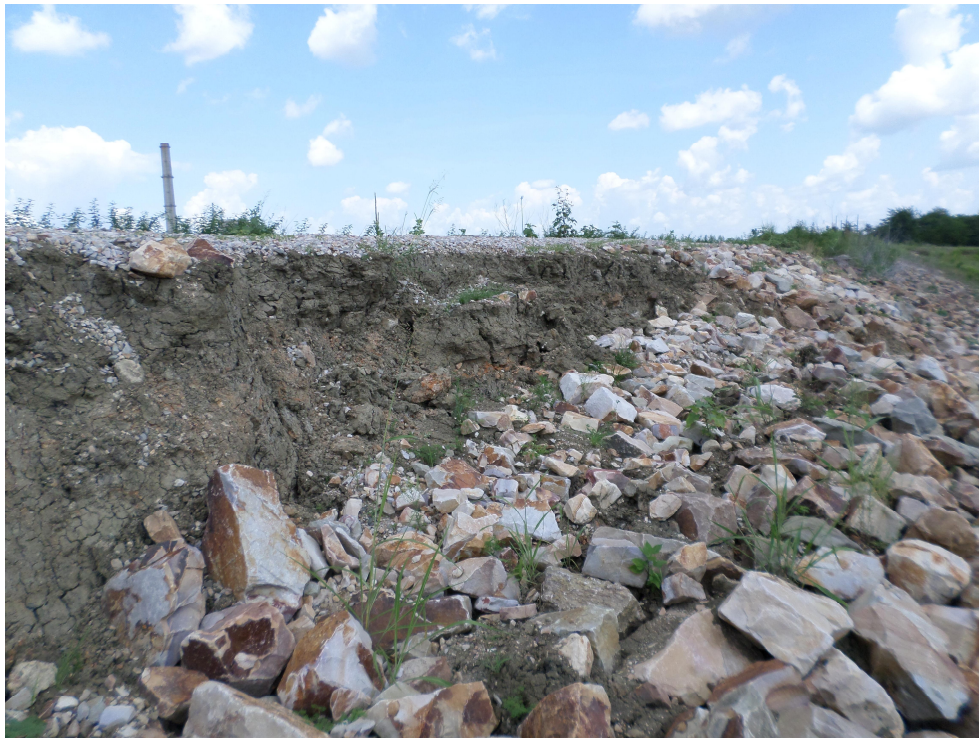
**No. 2** - Scarp of the Slide Near the Crest of the Embankment
