Re: CCR Impoundment Safety Factor Assessment
WFEC Hugo Power Plant
Hugo, Oklahoma
Terracon Project Number: 03171071

CCR Impoundment Safety Factor Assessment

WFEC Hugo Power Plant CCR Units 2 and 3 ■ Hugo, Oklahoma

November 28, 2017 ■ Terracon Project No. 03171071

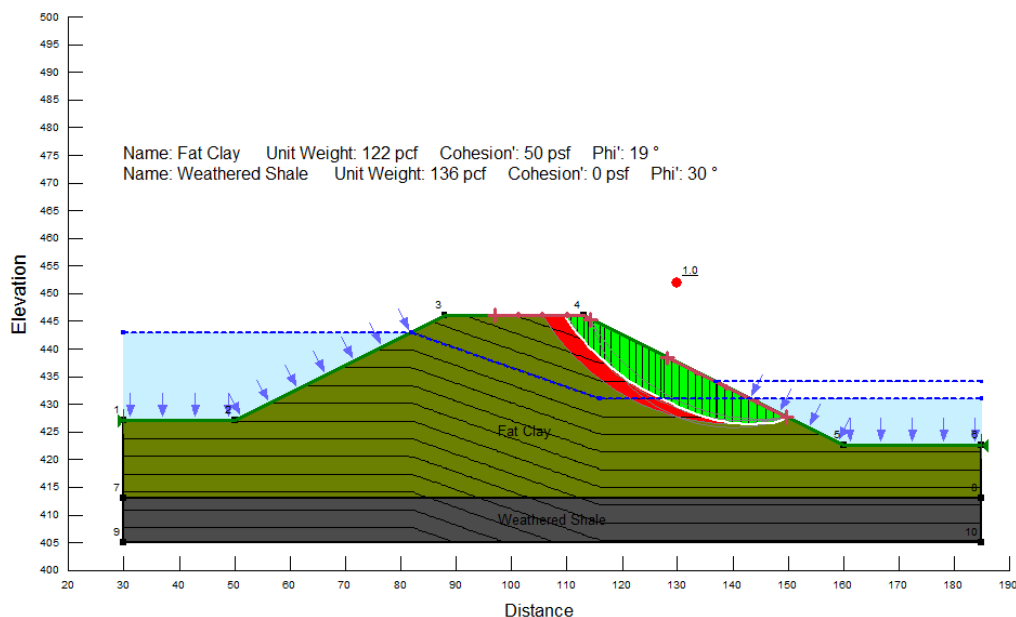
FIGURE 1: EXISTING 2H:1V SLOPE

For the back-calculation analysis of the failed slope, a target safety factor of 1 was used to analyze the existing slope. Soil parameters for each material and zone were varied within the anticipated ranges of fully softened and/or residual strength conditions until the factor of safety for the analyzed model reached approximately 1. The results of this back-calculation analysis are shown in Figure 1. The results of this analysis indicate a residual strength condition along the failure surface and normally consolidated (fully softened) conditions in the underlying native foundation soils. Although not shown in Figure 1, it is likely that the central core of the Impoundment's eastern embankment fill (away from the likely failure surface zone) still possesses apparent overconsolidated shear strength (higher cohesion and friction) due to the original compaction process and lack of weathering exposure.

The back-calculation results displayed in Figure 1 provide our best, pre-construction estimate of the most likely location of the aforementioned slide surface within CCR Unit 3's eastern embankment based upon the embankment soil parameters used and the slope geometry. The back-calculated, pre-construction estimate of the failure surface location was approximately 6 to 8 feet vertically below the existing embankment slope surface (about 8 to 10 feet normal to the slope surface). The actual location (depth and downslope extent) of the failure surface likely varied from the locus shown in Figure 1 due to material property, weathering and other variables not accounted for in the analysis. A pre-construction test trench into the embankment would have been required to accurately identify the precise depth, extent, and location of the failure surface.

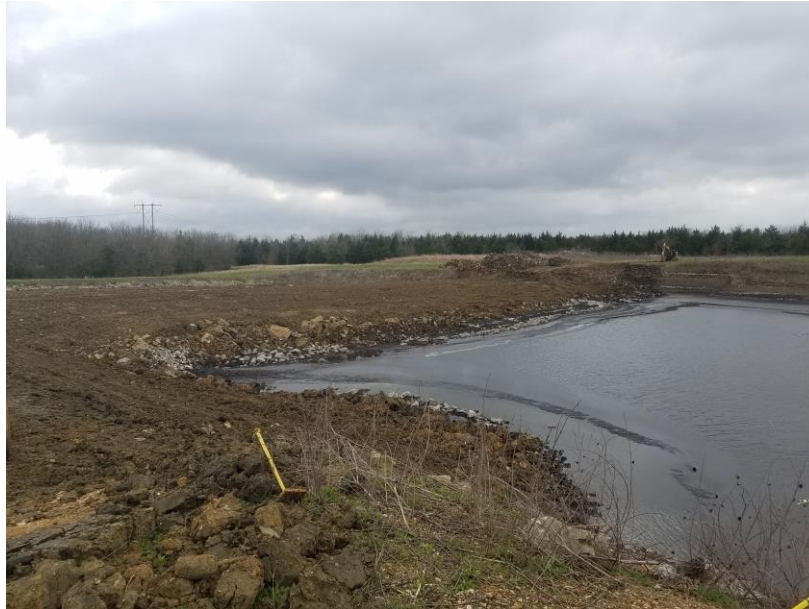
FIGURE 4: REMOVAL AND STOCKPILING OF THE EXISTING RIPRAP

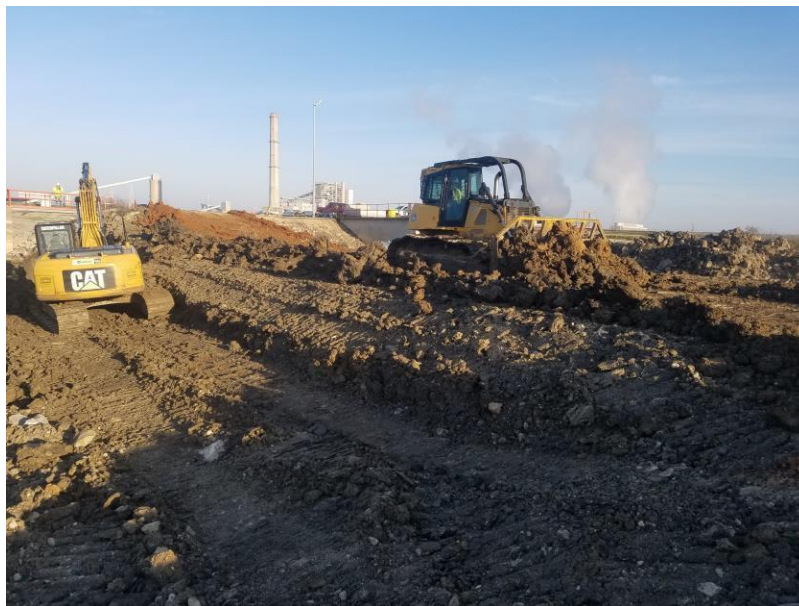
FIGURE 5: BEGINNING EARTHWORK OPERATIONS

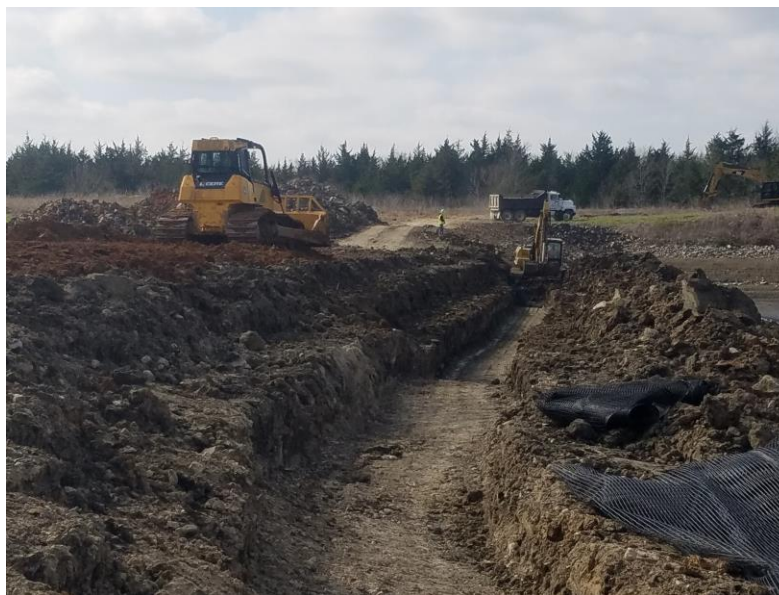
In the early stages of the earthwork operations, a slippage crack was discovered in the western face of the eastern embankment of CCR Unit 3. A Cardinal representative at the project site notified Terracon of this new development. A repair was designed that required the contractor to excavate the Western face of the eastern embankment of CCR Unit 3 to the bottom of the slippage crack and backfill the failed soil with imported borrow. This soil would be reinforced with geogrid that would be extended into benches cut into the existing eastern embankment.

FIGURE 6: EXCAVATING THE SOIL AROUND THE SLIPPAGE CRACK

Nation completes stripping off the top 8 feet of the CCR#3 dam. There was some substantial cracking and sliding of material along the CCR#3 side of the dam. This was documented by myself and Terracon.

Received phone call from Terracon to stop applying geogrid. The recommendation from Terracon was to dig out the area where the crack formed. I then notified Paul Luhring regarding the recommended additional scope of work.

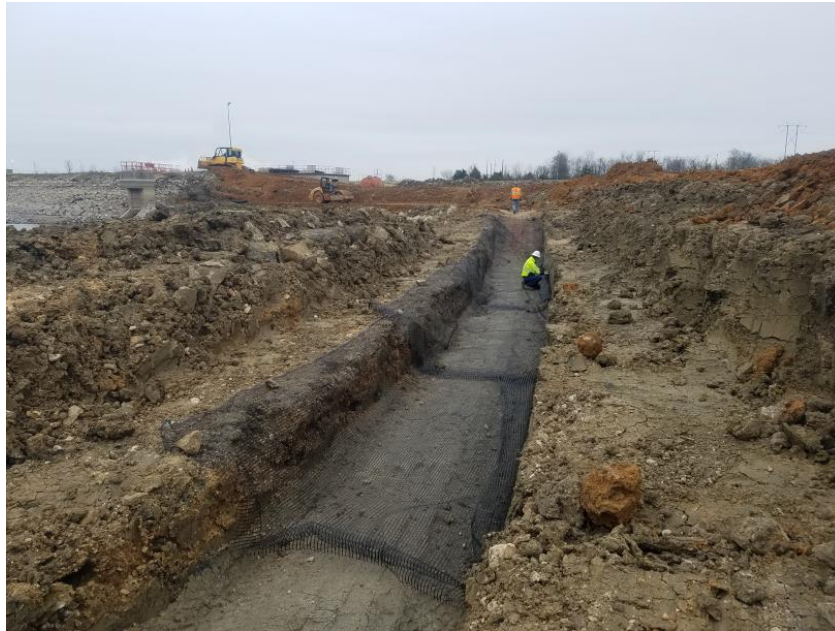
FIGURE 7: REINFORCING THE TRENCH WITH GEOGRID

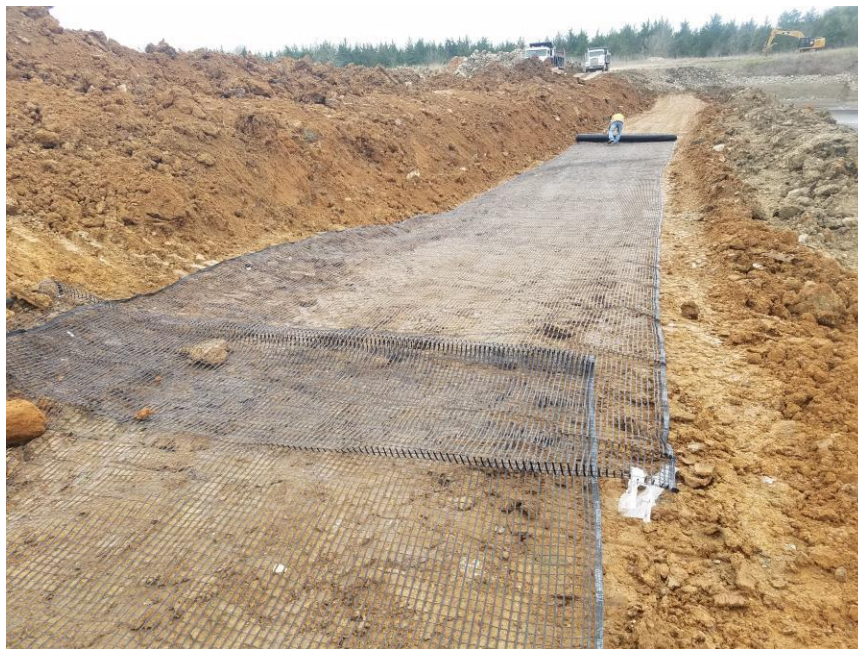
FIGURE 8: THE TRENCH BACKFILLED AND SECURED TO THE EMBANKMENT WITH GEOGRID

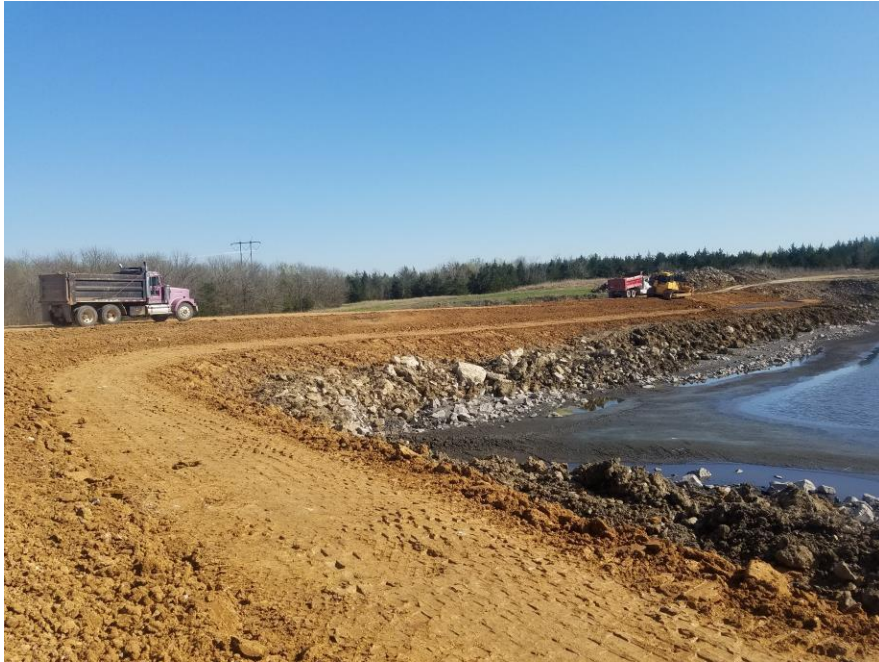
FIGURE 9: ADDITIONAL FILL IS DELIVERED AND PLACED ON THE EMBANKMENT

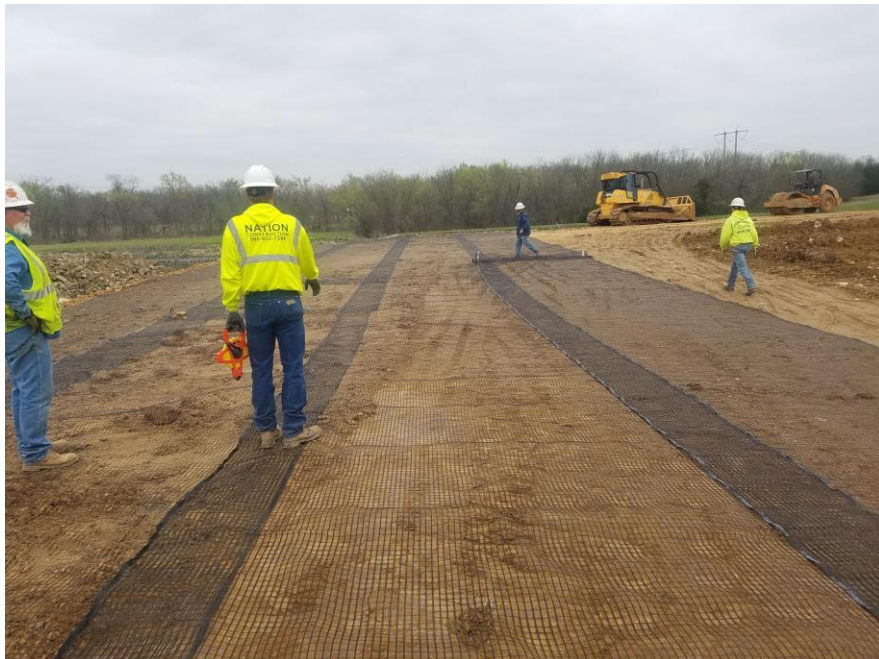
FIGURE 10: FIRST LAYER OF GEOGRID FOR THE UPPER 8 FEET OF THE EMBANKMENT

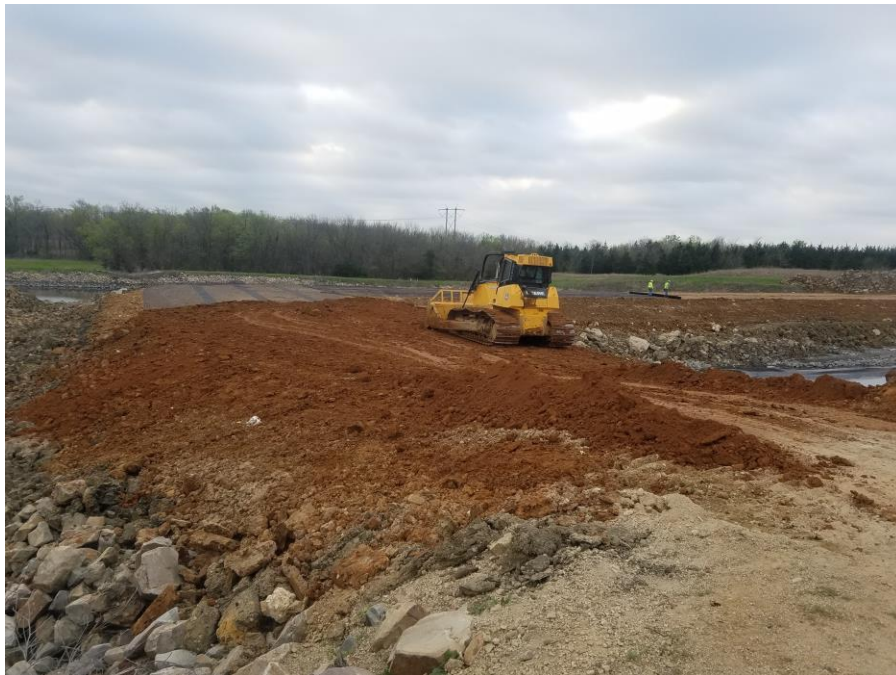
FIGURE 11: FILL PLACED OVER GEOGRID

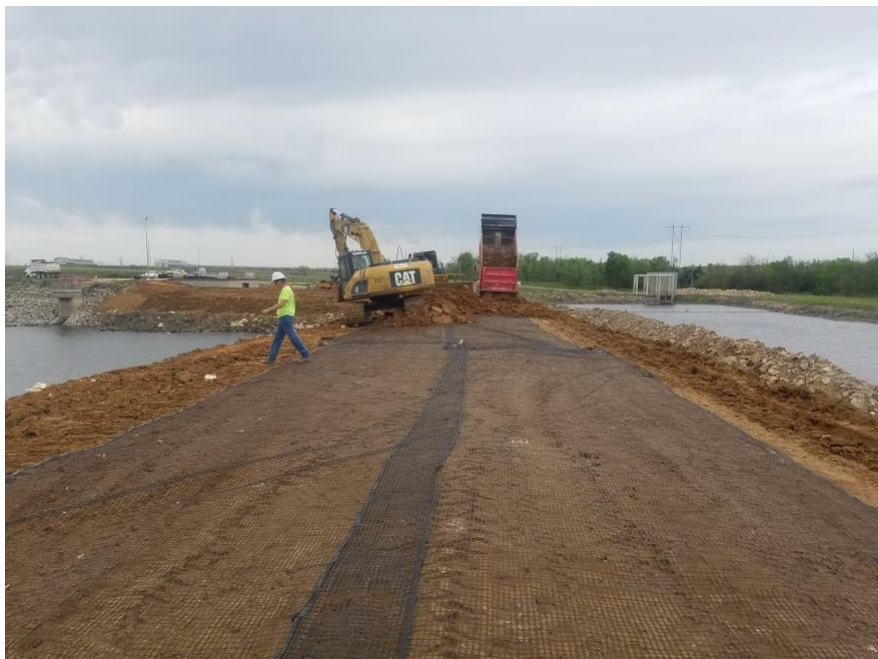
FIGURE 12: ADDITIONAL LAYERS OF GEOGRID AND FILL ARE PLACED TO BRING EMBANKMENT UP TO FINAL GRADE

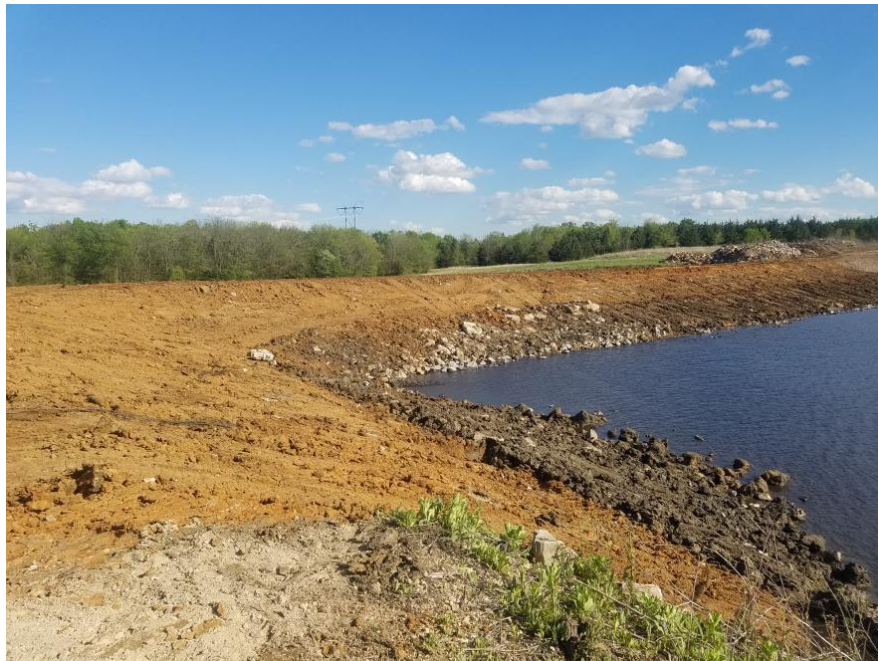
FIGURE 13: FINAL LAYER OF FILL WAS PLACED ON APRIL 5, 2017

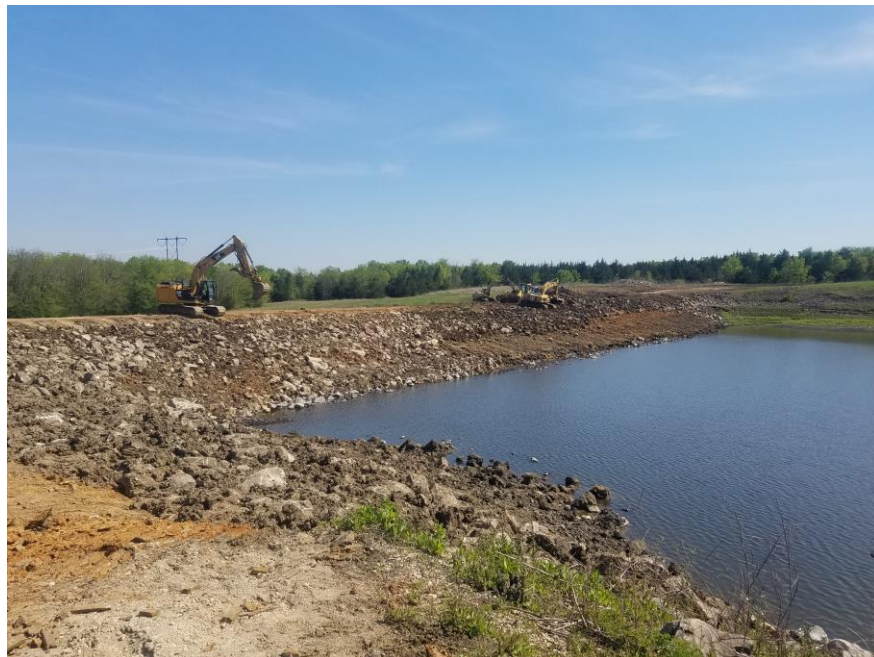
FIGURE 14: PLACEMENT OF RIPRAP FOR SLOPE PROTECTION

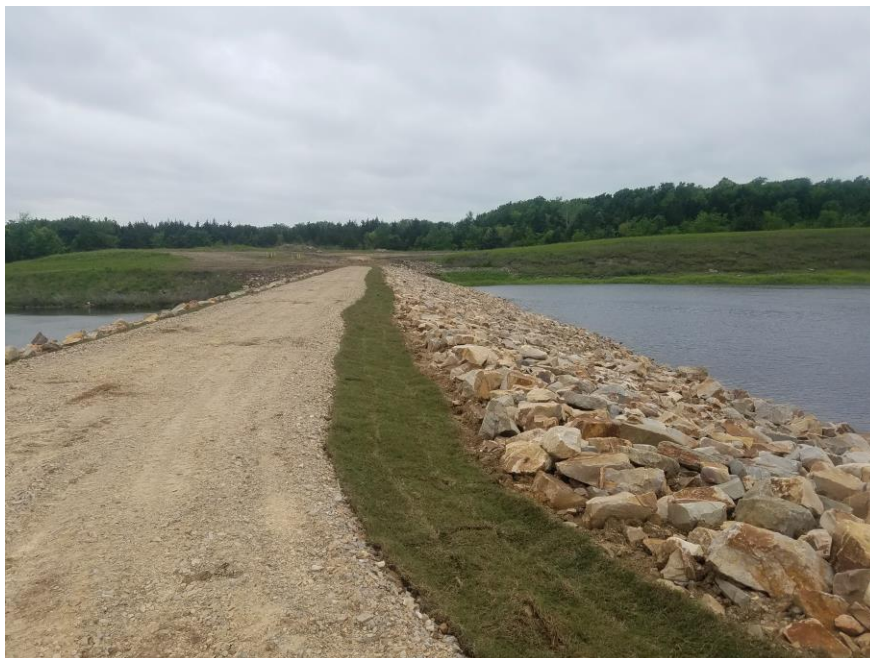
FIGURE 15: COMPLETED CCR UNIT 3 EASTERN EMBANKMENT FOR PHASE 1 OF THE PROJECT

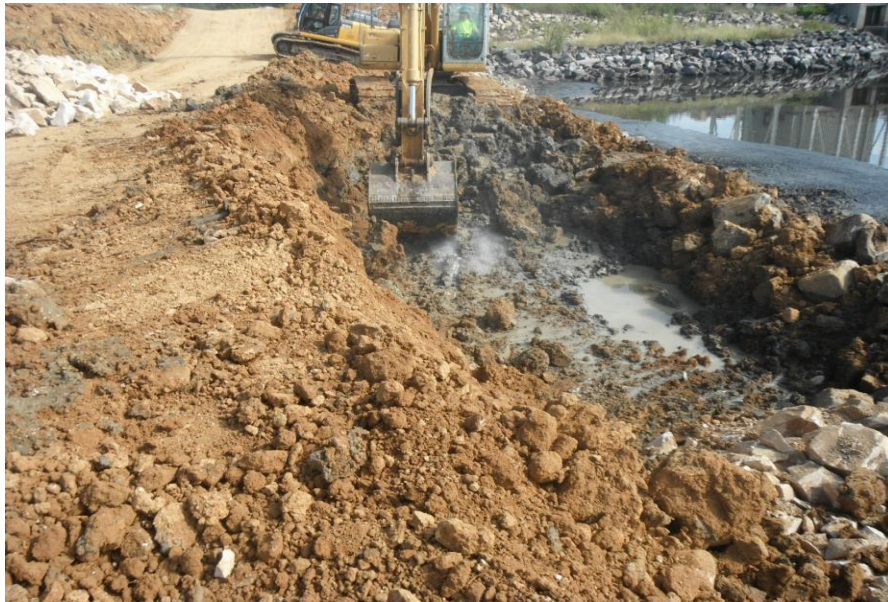
FIGURE 17: EXCAVATION OF TOE TRENCH FOR ROCK TOE BERM

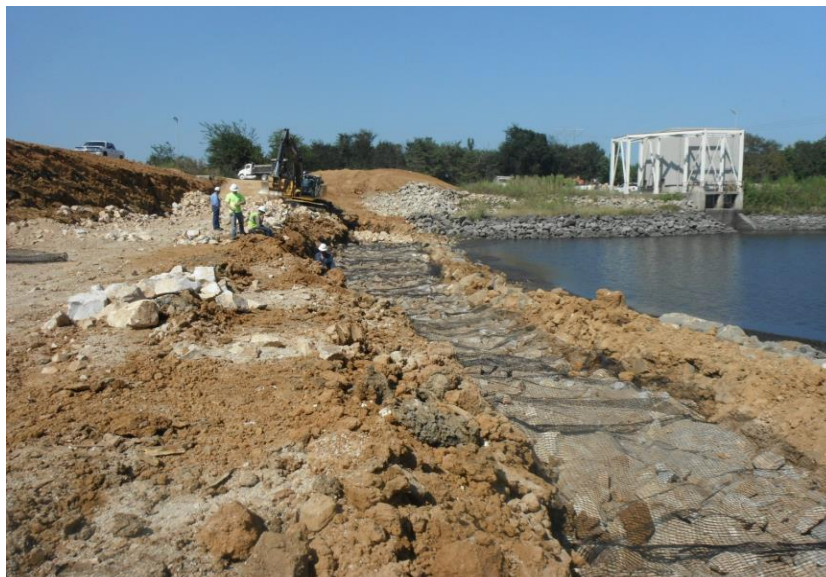
FIGURE 18: PLACEMENT OF ROCK AND GEOGRID IN ROCK TOE BERM

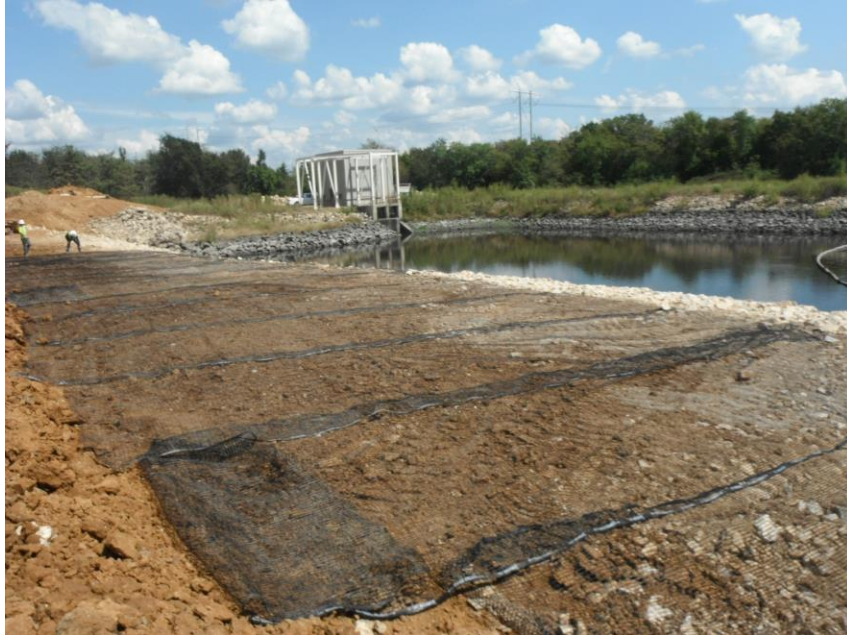
FIGURE 19: PLACEMENT OF GEOGRID TO SECURE ROCK TOE BERM TO EMBANKMENT

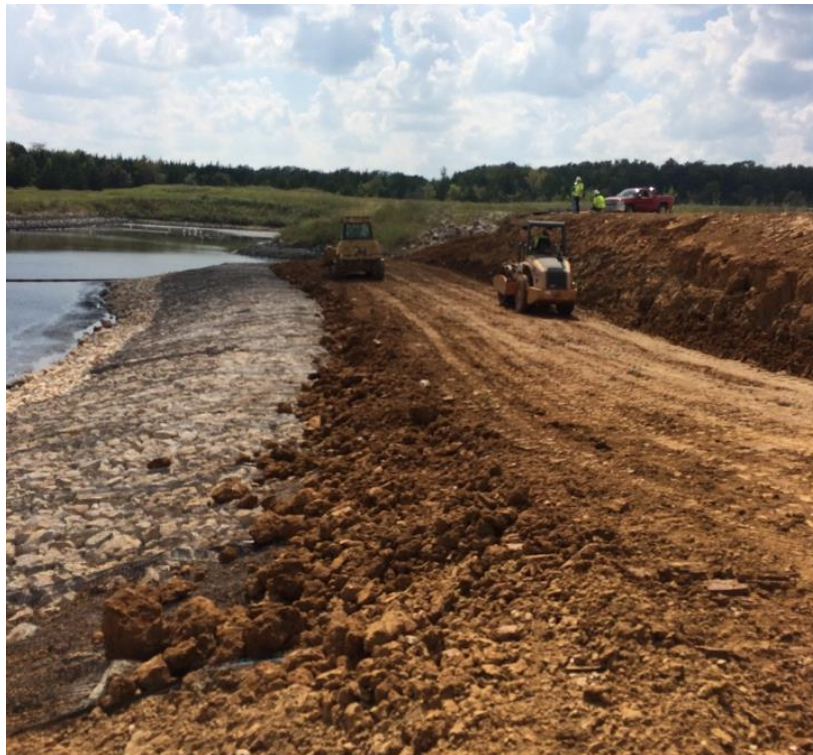
FIGURE 20: PLACEMENT OF ADDITIONAL FILL BENCHED INTO THE EMBANKMENT

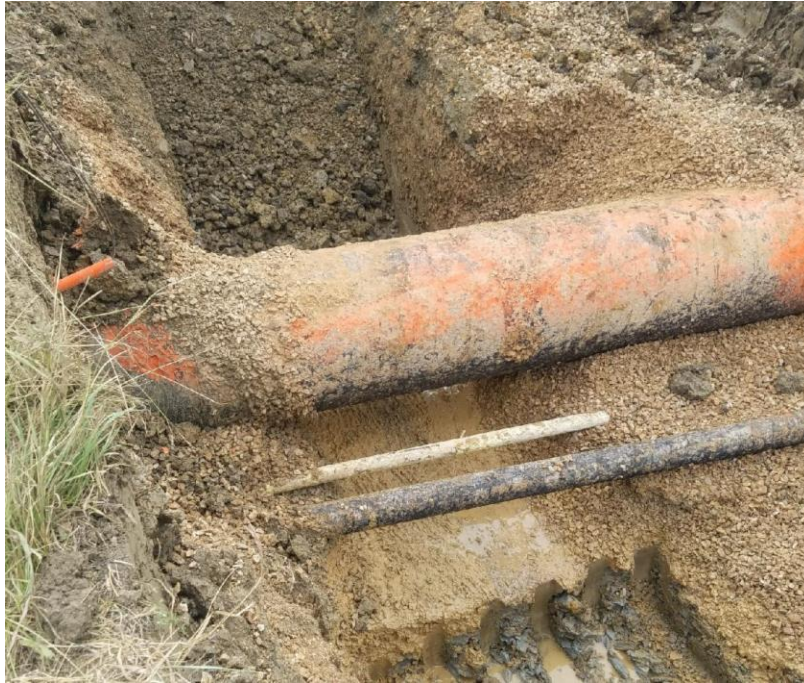
FIGURE 21: HYDROVAC EXCAVATION TO EXPOSE BURIED UTILITIES

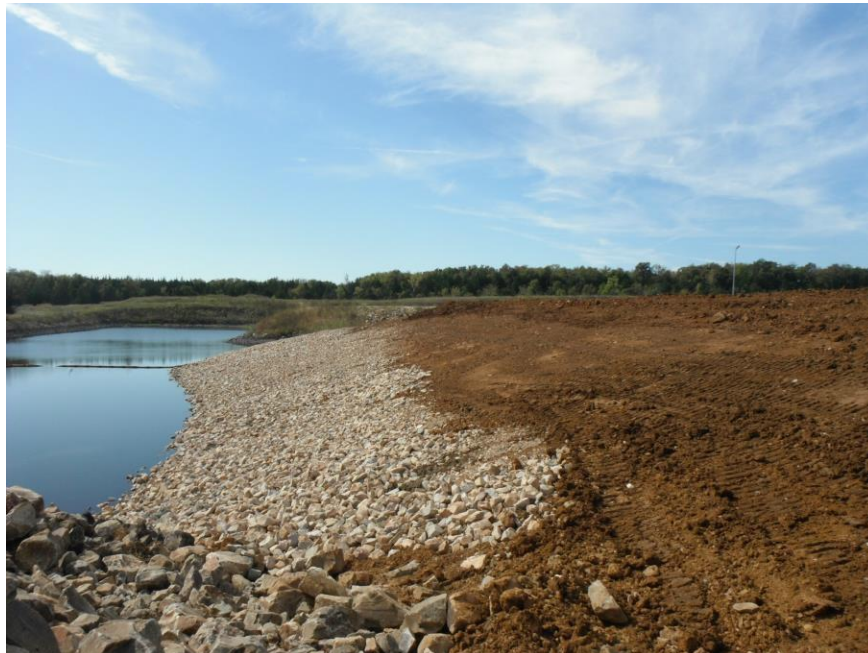
FIGURE 22: COMPLETION OF CCR UNIT 2 EASTERN EMBANKMENT PRIOR TO PLACEMENT OF RIPRAP

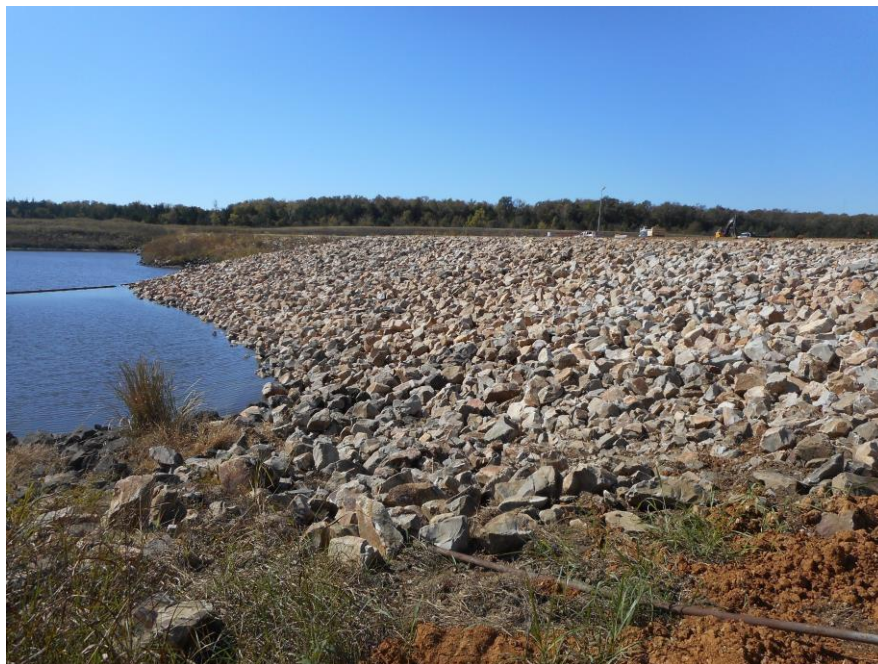
FIGURE 23: COMPLETION OF CCR UNIT 2 EASTERN EMBANKMENT WITH RIPRA PROTECTION
