# WESTERN FARMERS ELECTRIC COOPERATIVE

October 17, 2016  
Combined Initial Hazard  
Potential Classification,  
Structural Stability, and Safety  
Factor Assessment Report

**OK00032129**

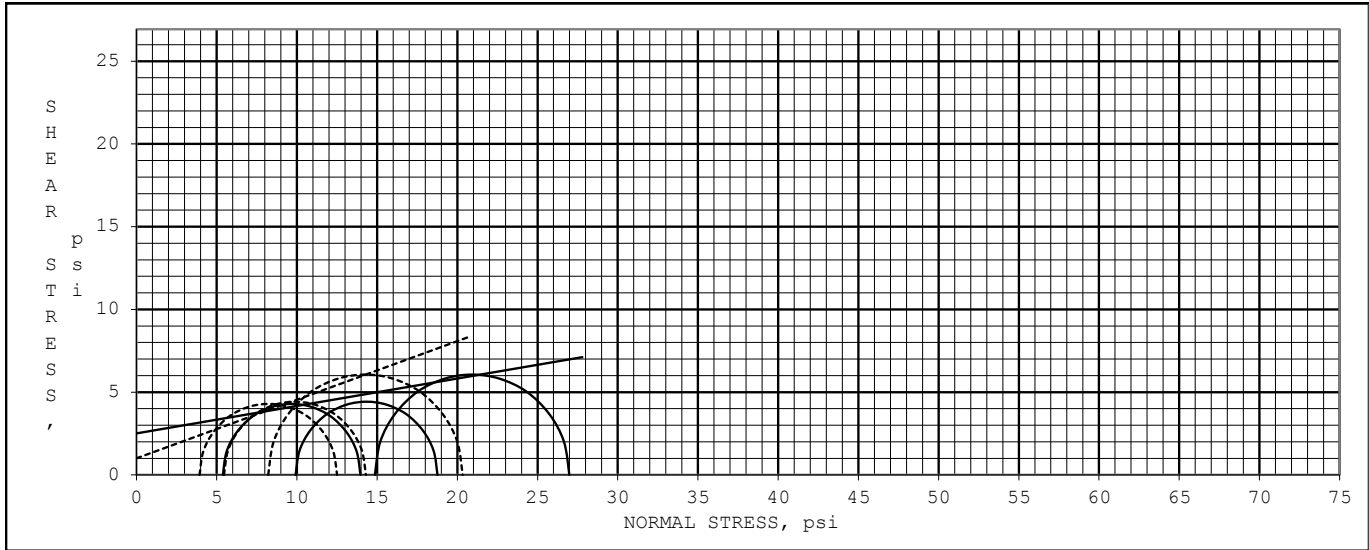
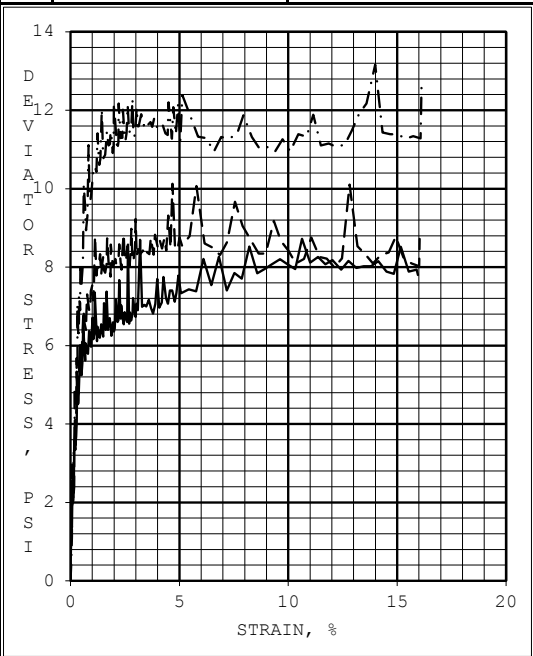
PROCEDURE: ASTM D4767, CONSOLIDATED-UNDRAINED TRIAXIAL COMPRESSION TEST ON COHESIVE SOILS

EFFECTIVE STRESS ---	ANGLE OF INTERNAL FRICTION, deg	<b>19.5</b>	COHESION, psi	<b>1.0</b>
TOTAL STRESS —	ANGLE OF INTERNAL FRICTION, deg	<b>9.4</b>	COHESION, psi	<b>2.5</b>

SPECIMEN ID:		A	B	C			
INITIAL	WATER CONTENT, %	27.8	31.6	27.3			
	DRY DENSITY, pcf	95.6	92.1	96.9			
	SATURATION, %	98	103	100			
	VOID RATIO	0.76	0.83	0.74			
BEFORE SHEAR	WATER CONTENT, %	28.1	29.7	26.1			
	DRY DENSITY, pcf	95.8	93.5	98.8			
	SATURATION (B PARAMETER)	0.97	0.96	0.97			
	VOID RATIO	0.76	0.80	0.70			
	FINAL BACK PRESSURE, psi	99.0	99.4	99.1			
MINOR PRINCIPAL STRESS, psi		5.4	9.9	14.9			
EFFECTIVE STRESS PEAK AT % STRAIN		2.6	2.4	2.6			
EFF. DEVIATOR STRESS AT PEAK STRAIN, psi		8.6	8.8	12.1			
TOTAL STRESS PEAK AT % STRAIN		2.6	2.4	2.6			
TOTAL DEVIATOR STRESS AT PEAK STRAIN, psi		8.6	8.8	12.1			
ULTIMATE DEVIATOR STRESS (15% STR), psi		8.2	8.7	11.3			
SAMPLE TYPE: 3" SHELBY TUBE		TIME TO 50% PRIMARY CONSOLIDATION, min	8.19	10.00	13.00		
DESCRIPTION OF SPECIMENS: FAT CLAY (WEATHERED SHALE), YELLOWSIH BROWN WITH BROWN & GRAYISH BROWN		STRAIN RATE, % / hour	1.09	1.10	1.11		
		INITIAL DIAMETER, inch	1.362	1.367	1.362

INITIAL HEIGHT, inch	2.864	2.907	2.877		
LL 65	PL 25	PI 40	Gs 2.7 EST.	AREA AFTER CONSOLIDATION, inch <sup>2</sup>	1.447	1.447	1.433
PROJECT NO. 03165346 (03165139)		PROJECT: WFEC HUGO POWER PLANT EMBANKMENT INVESTIGATION					
		BORING #: B-2					
LABORATORY: TERRACON - LENEXA		SAMPLE #: 4					
DATE: 6/2/2016		DEPTH, feet: 8.0 - 10.0

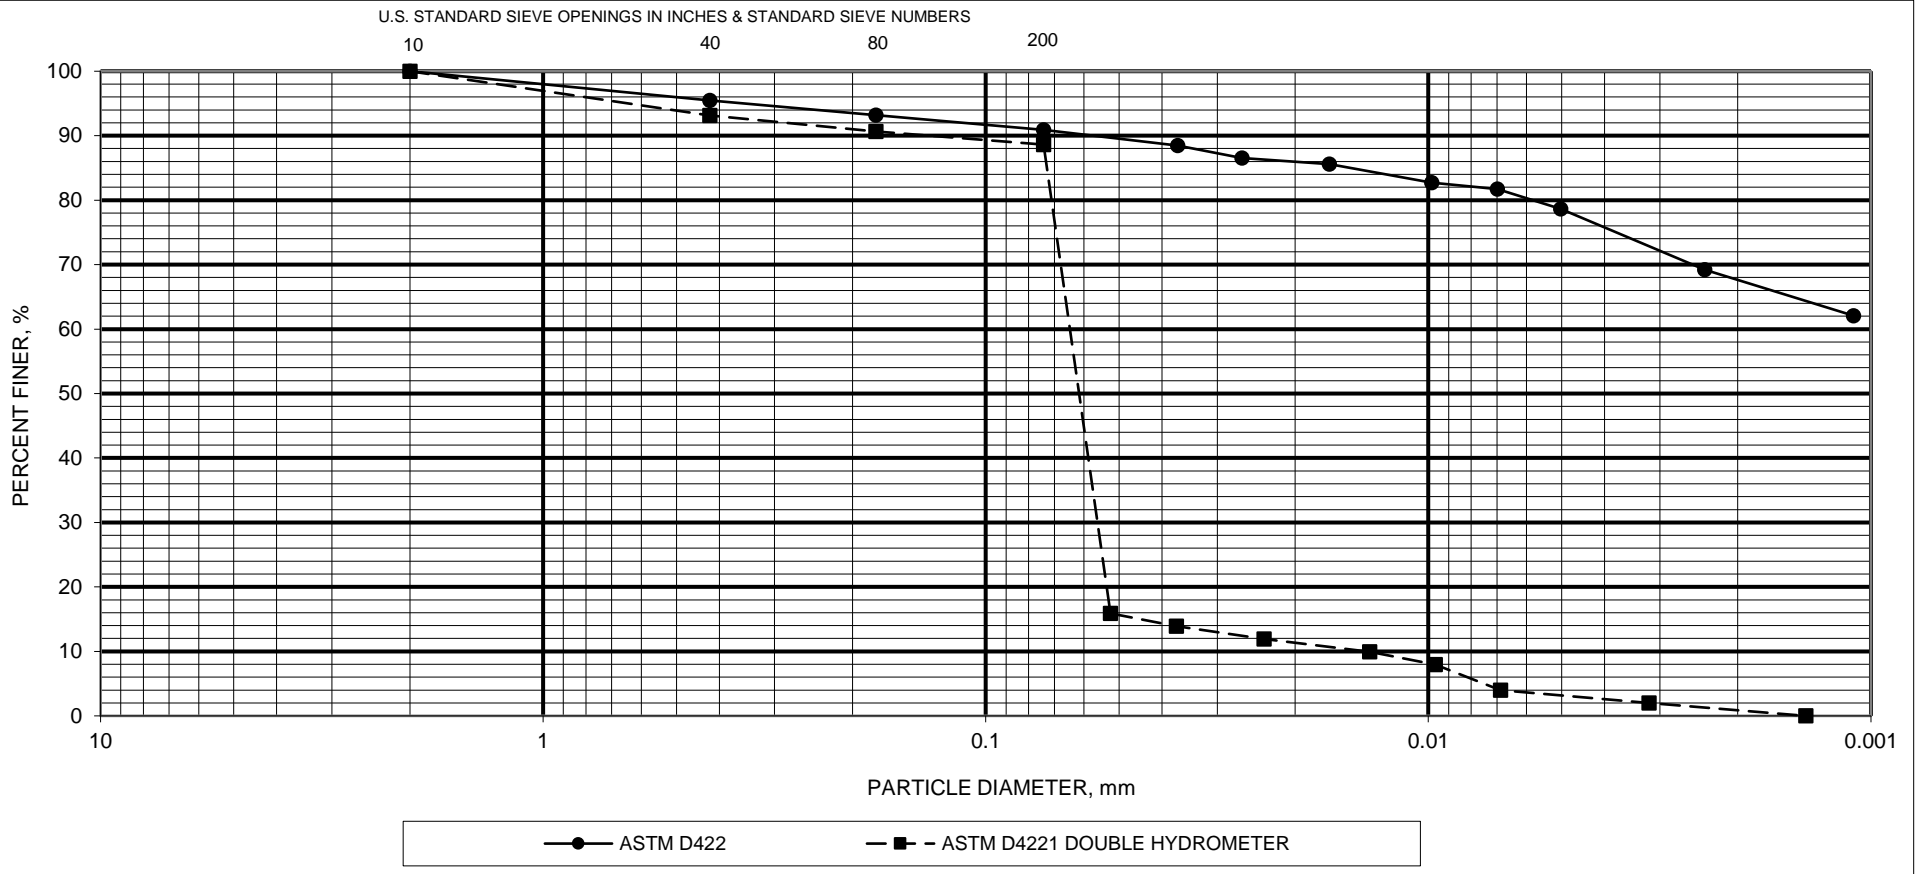
**ASTM D4221 GRAIN SIZE DISTRIBUTION CURVES**

ASTM D442, % 0.005mm	79	ASTM D4221 DOUBLE HYDROMETER, % 0.005 mm	3	DISPERSION, %	4
----------------------	----	--	---	---------------	---

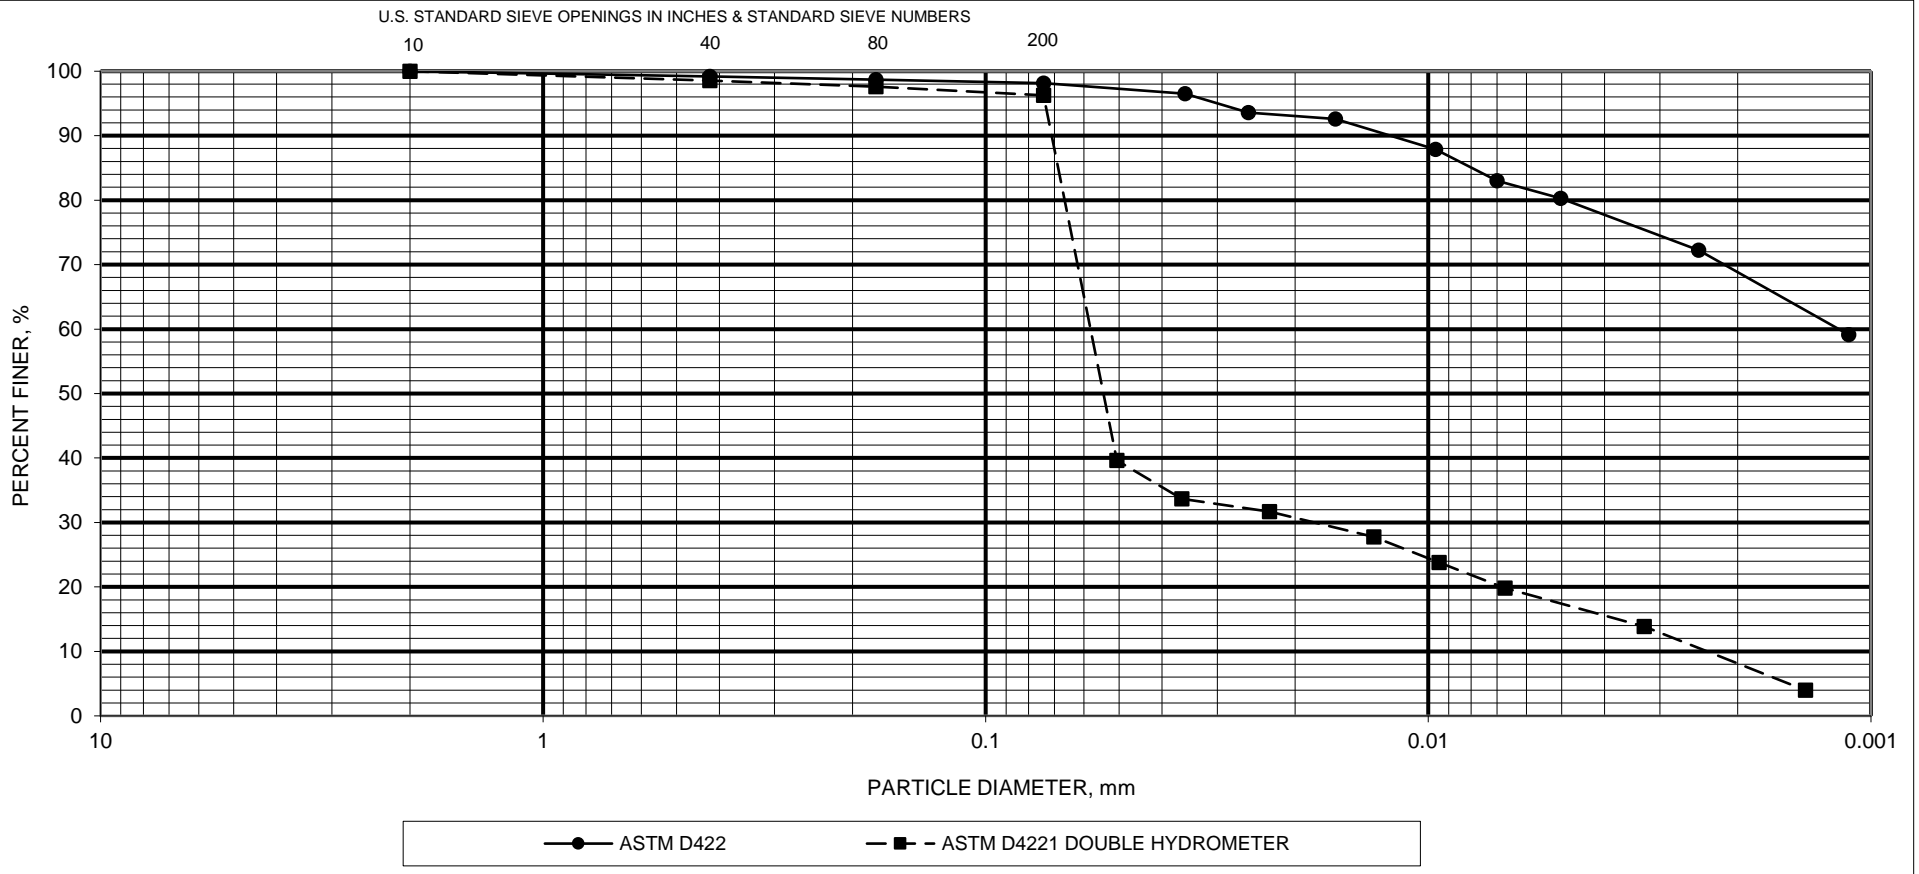
**ASTM D4221 GRAIN SIZE DISTRIBUTION CURVES**

ASTM D442, % 0.005mm	80	ASTM D4221 DOUBLE HYDROMETER, % 0.005 mm	18	DISPERSION, %	23
----------------------	----	--	----	---------------	----
