DG units to energize Tuttle Substation; WFEC crews focus on widespread issues

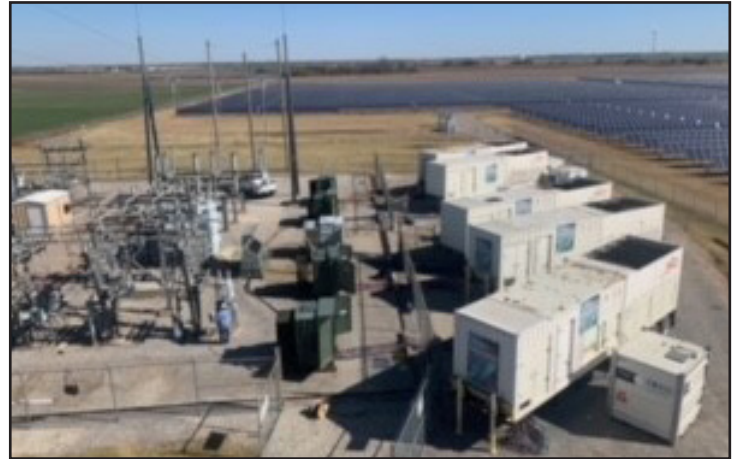
Distributed generation (DG) units have been placed at the Tuttle Substation and are set to be energized around noon today. This step will help energize that site while transmission repairs continue.

Distributed generation (DG) units are set to be energized around noon today at the Tuttle Substation, which will help energize that site while transmission repairs continue. This step will also allow Oklahoma Electric Cooperative (OEC) to return service to their members in this area, some of which has also been backedf to help in returning service to this heavily damaged area.
